**SUPPLEMENT TO WATER COMPLIANCE INSPECTION REPORT FORM  
(EPA FORM 3560-3 (REV 9-94))**

**JOSE DE DIEGO STREET (PR-47) STORM WATER AND  
WASTEWATER COLLECTION SYSTEMS**

Reconnaissance Inspection: Autonomous Municipality of San Juan (MSJ) Municipal Separate Storm Sewer System (MS4)  
National Pollutant Discharge Elimination System (NPDES) Permit PRR040036

Inspection Date: July 6, 2015

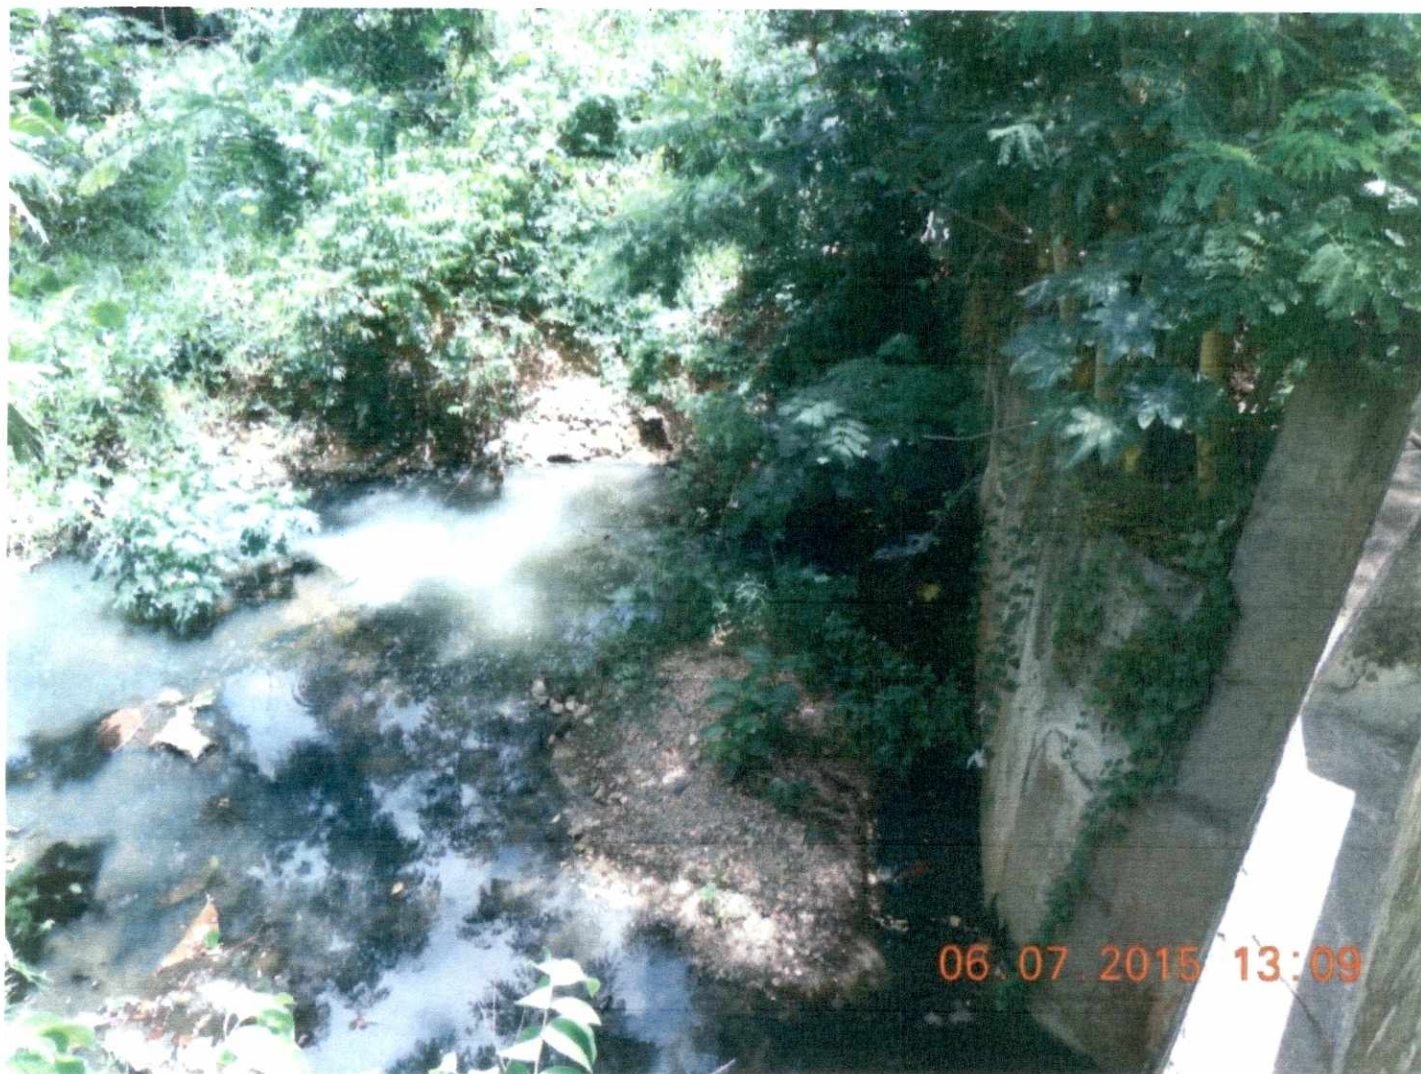
1. Strong wastewater odor and other wastewater characteristics (e.g. color, solids, and algae formation) were observed in the Juan Méndez Creek from the José De Diego Street Bridge that crosses the creek. For more details refer to photo DSCN2297 located in **Attachment I** of this report. Coordinates: Lat. 18° 23' 53.33" N – Long. 66° 2' 31.30" W.
2. A steady and moderate dry-weather flow with wastewater appearance (e.g., odor, color, algae) was observed being discharged thru an approximately 30 inch diameter pipe located at the west side of the Juan Méndez Creek and the José De Diego (PR-47) bridge.
3. PRASA and MSJ were notified about the inspection findings via email on July 7, 2015, the email can be found in **Attachment II** of this report.

**DSCN2297** – Partial view of the Juan Méndez Creek and the approximately 30 inch diameter pipe discharging dry-weather flow with wastewater characteristics (odor, color, algae formation) located in the southwest part of the José De Diego Street Bridge that crosses the Juan Méndez Creek.

MSJ and PRASA shall take the necessary actions to cease discharging wastewaters into Waters of the United States. The response to this report shall include all the details, evidence, and results of such actions.

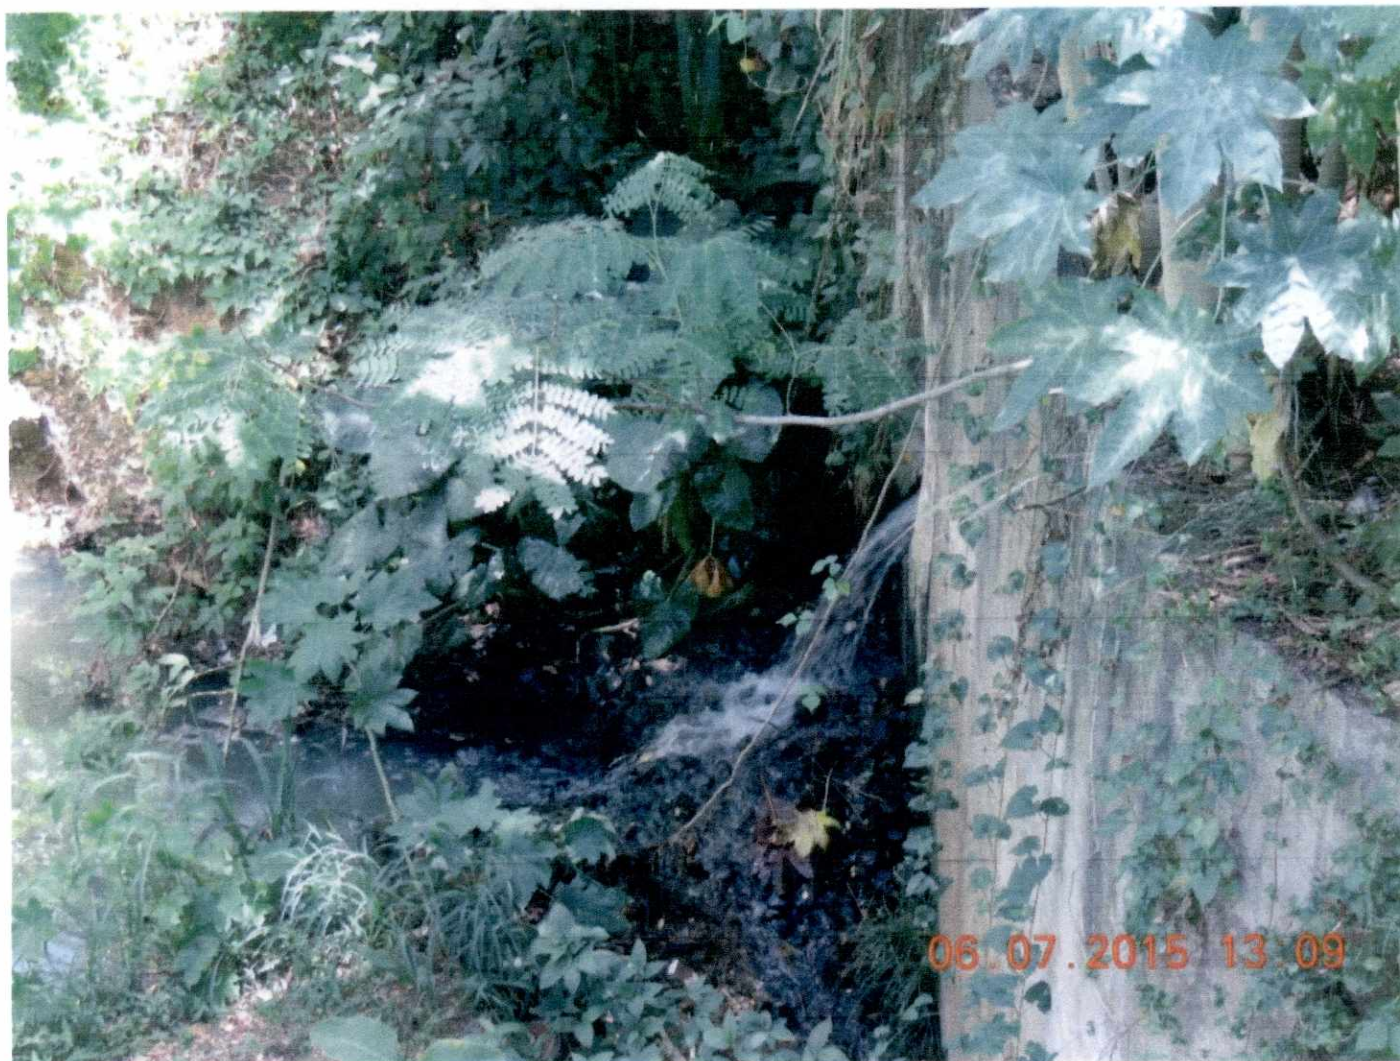
**DSCN2298** – Partial view of the approximately 30 inch diameter pipe discharging dry-weather flow with wastewater characteristics (odor, color, algae formation) located in the southwest part of the José De Diego Street Bridge that crosses the Juan Méndez Creek.

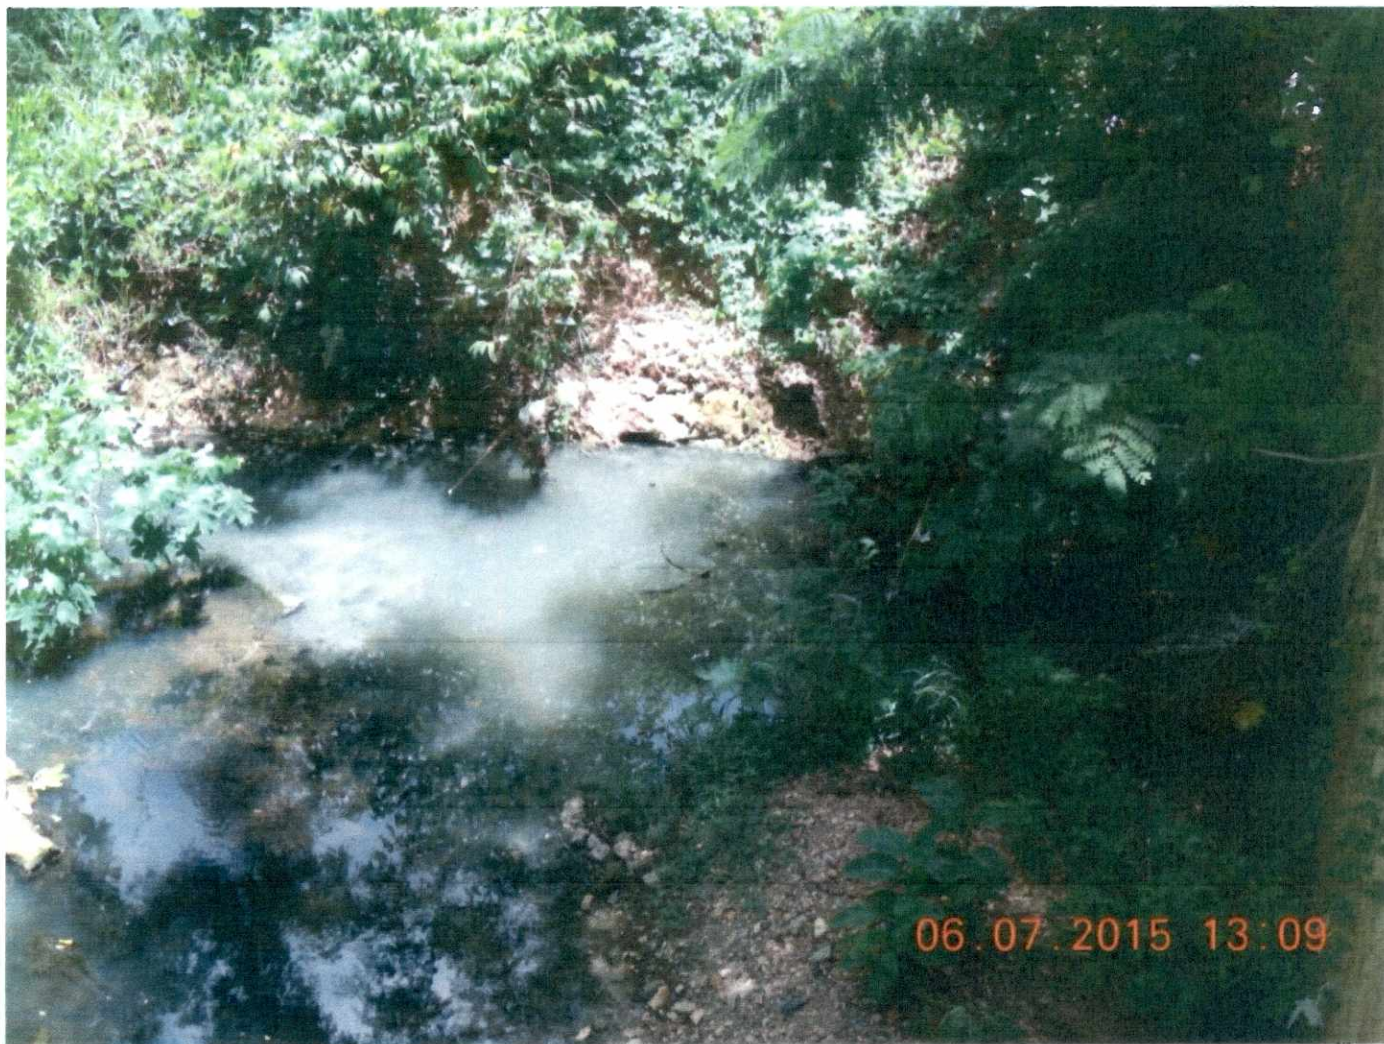
**DSCN2299** – Additional view of the Juan Méndez Creek viewed from the José De Diego Street Bridge. Significant amounts of dry-weather flow with wastewater characteristics (odor, color, algae formation) were observed reaching the creek.

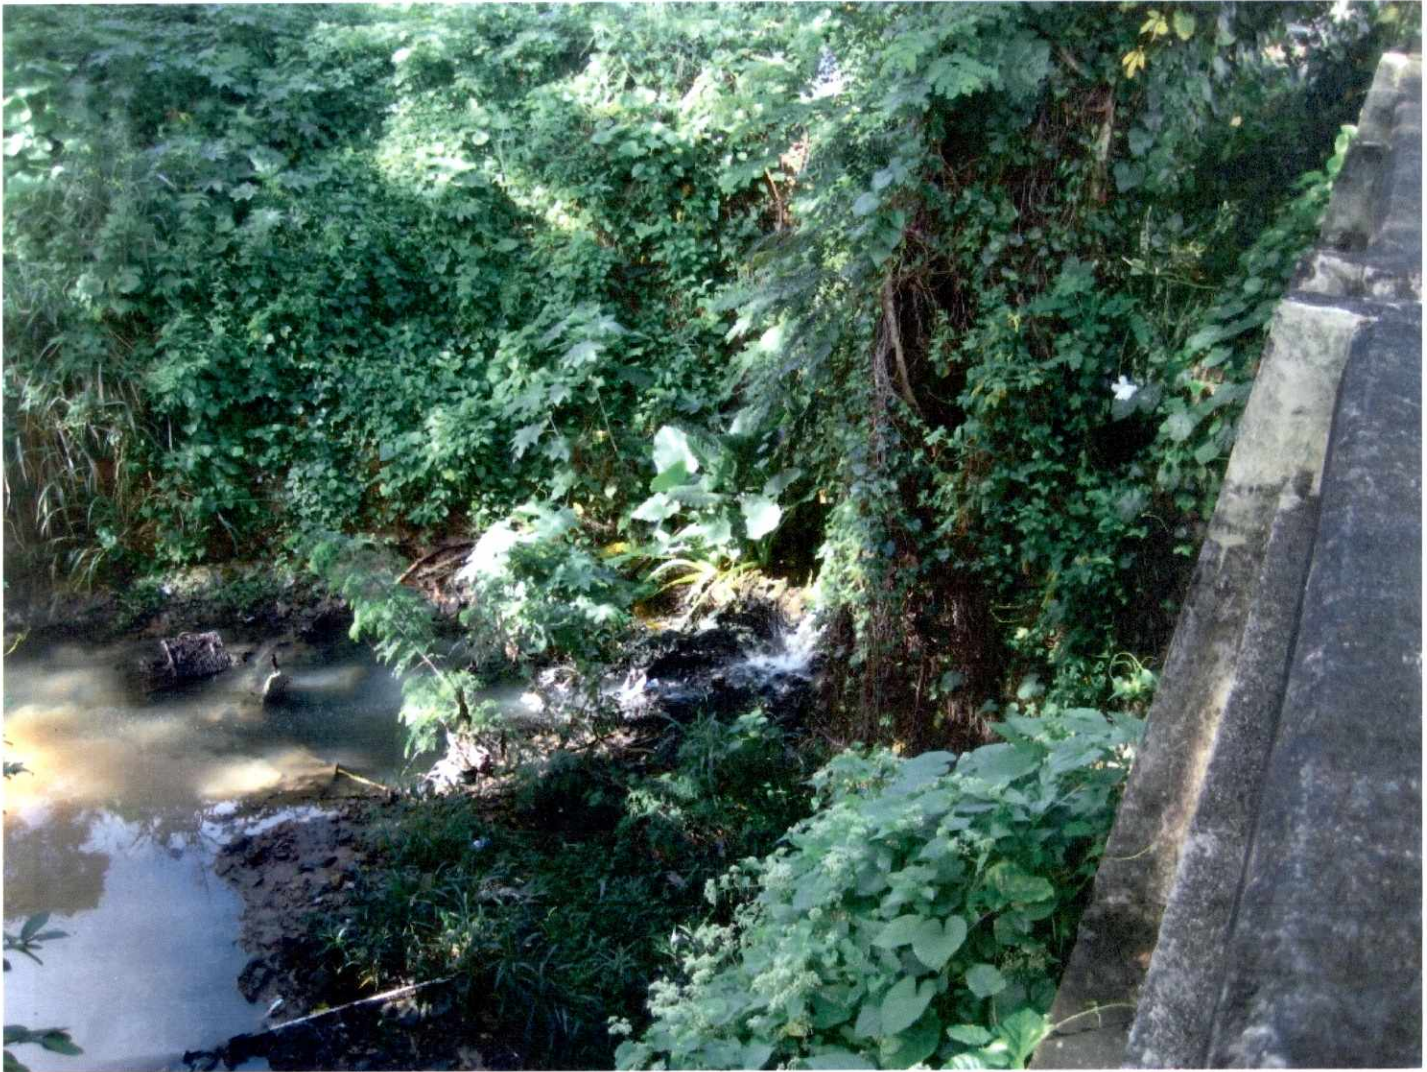
**November 23, 2011**

**IMG\_2344** – Photo taken on November 23, 2011 by EPA Inspector Alex O. Rivera. Partial view of the Juan Méndez Creek and the approximately 30 inch diameter pipe discharging dry-weather flow with wastewater characteristics (odor, color, algae formation) located in the southwest part of the José De Diego Street Bridge that crosses the Juan Méndez Creek.

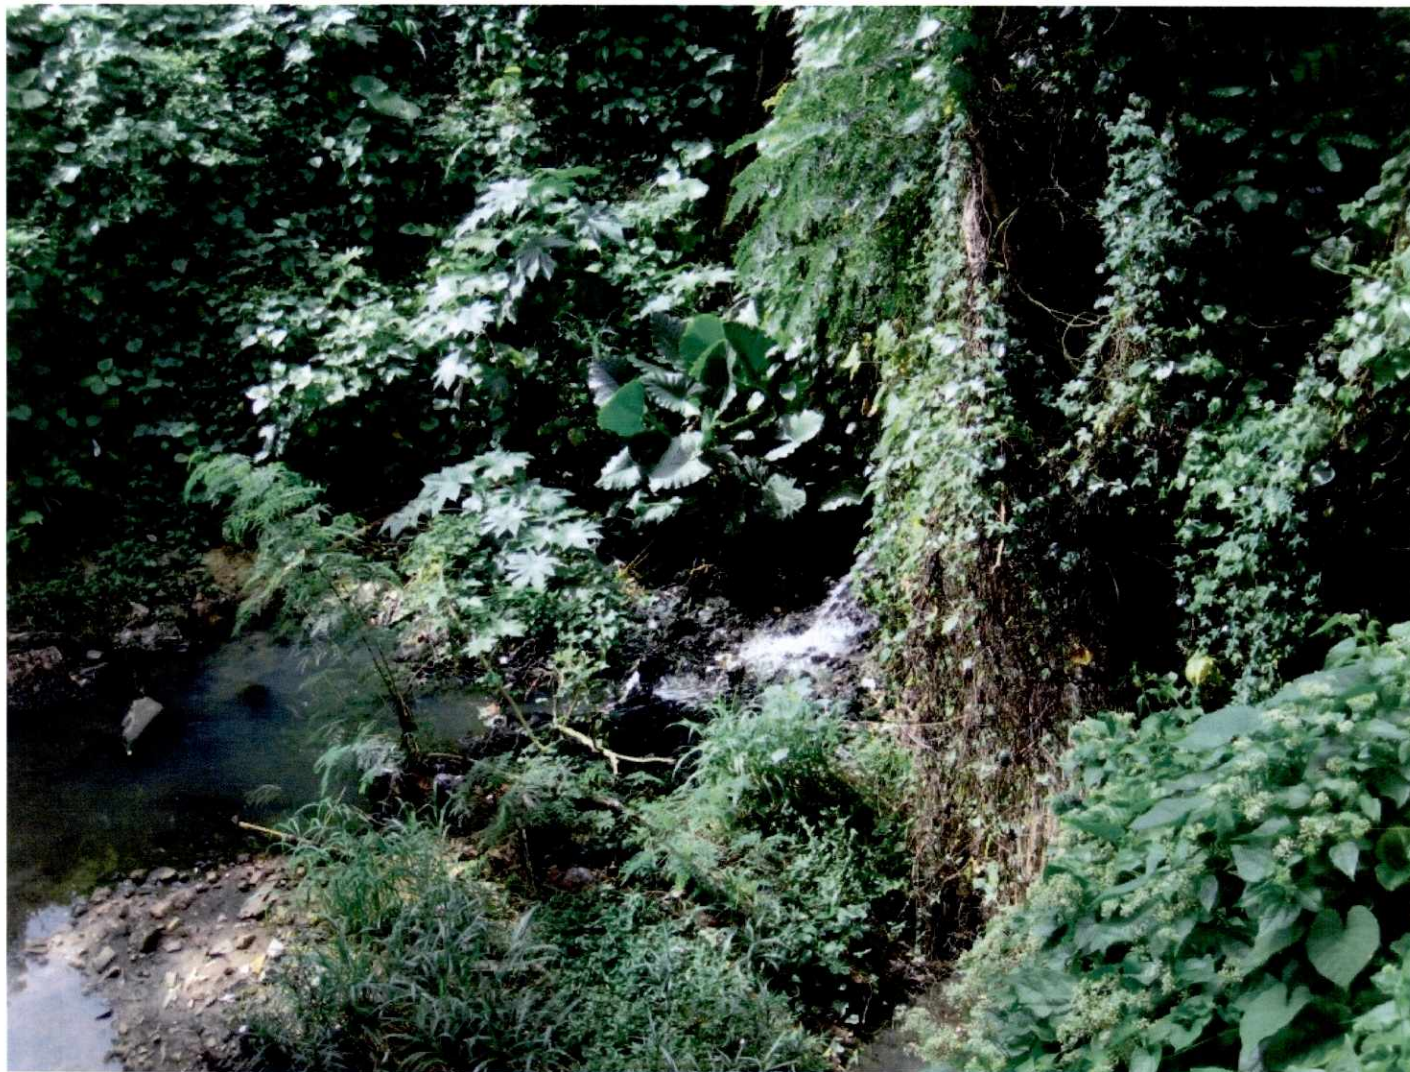
**December 1, 2011**

**IMG\_2400** – Photo taken on December 1, 2011 by EPA Inspector Alex O. Rivera. Additional view of the approximately 30 inch diameter pipe discharging dry-weather flow with wastewater characteristics (odor, color, algae formation) located in the southwest part of the José De Diego Street Bridge that crosses the Juan Méndez Creek.

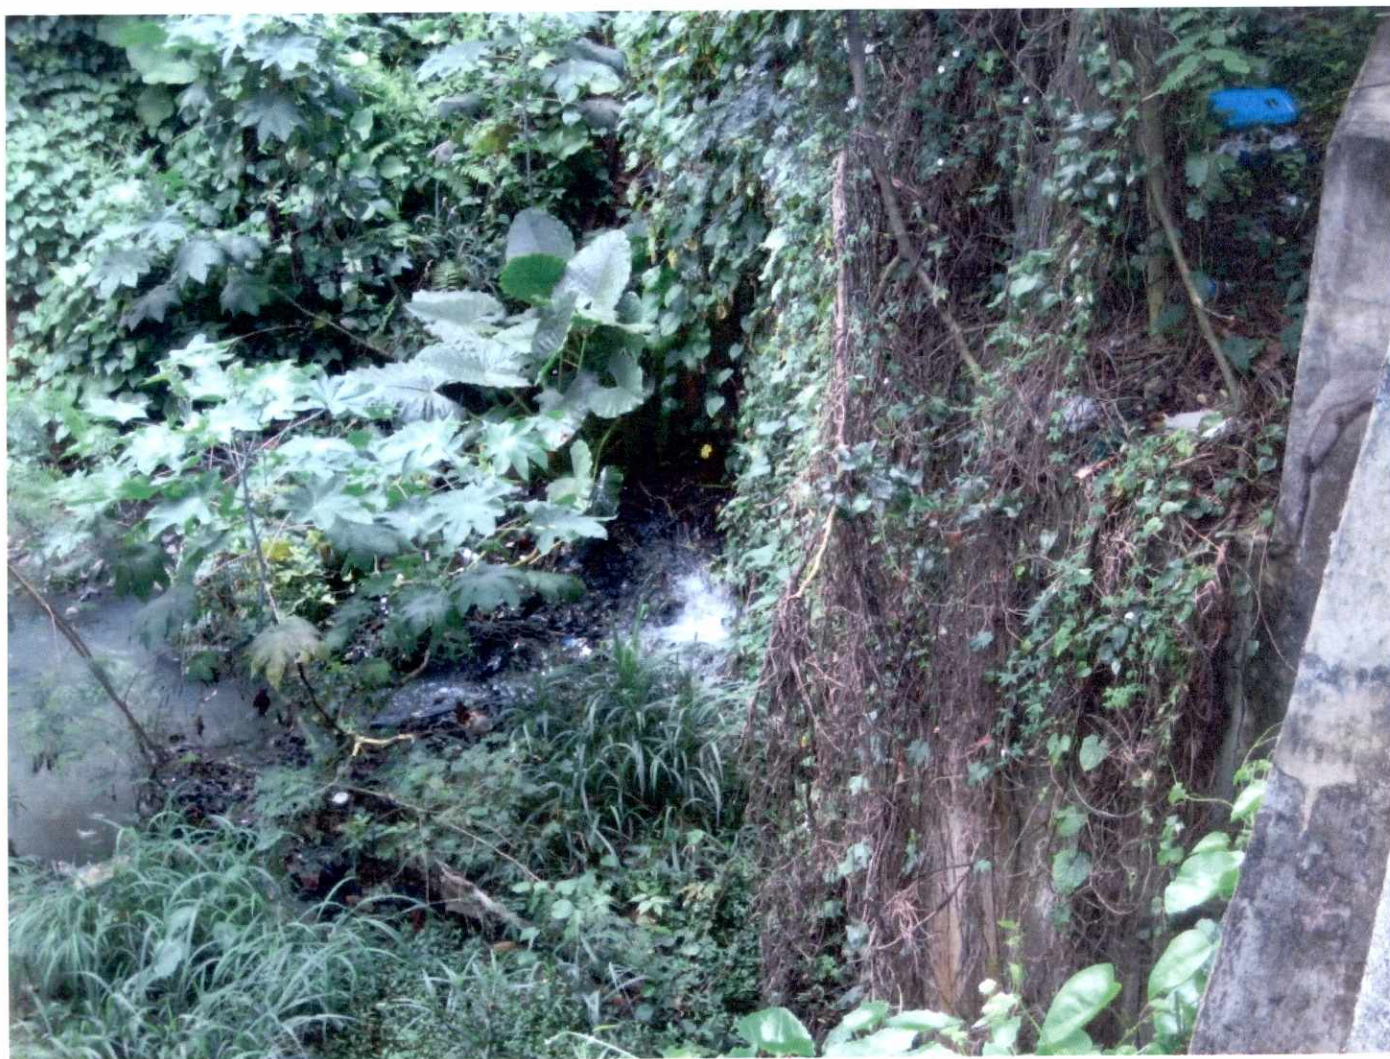
**February 16, 2012**

**IMG\_2638** – Photo taken on February 16, 2012 by EPA Inspector Alex O. Rivera. Additional view of the Juan Méndez Creek viewed from the José De Diego Street Bridge. Significant amounts of dry-weather flow with wastewater characteristics (odor, color, algae formation) were observed reaching the creek.

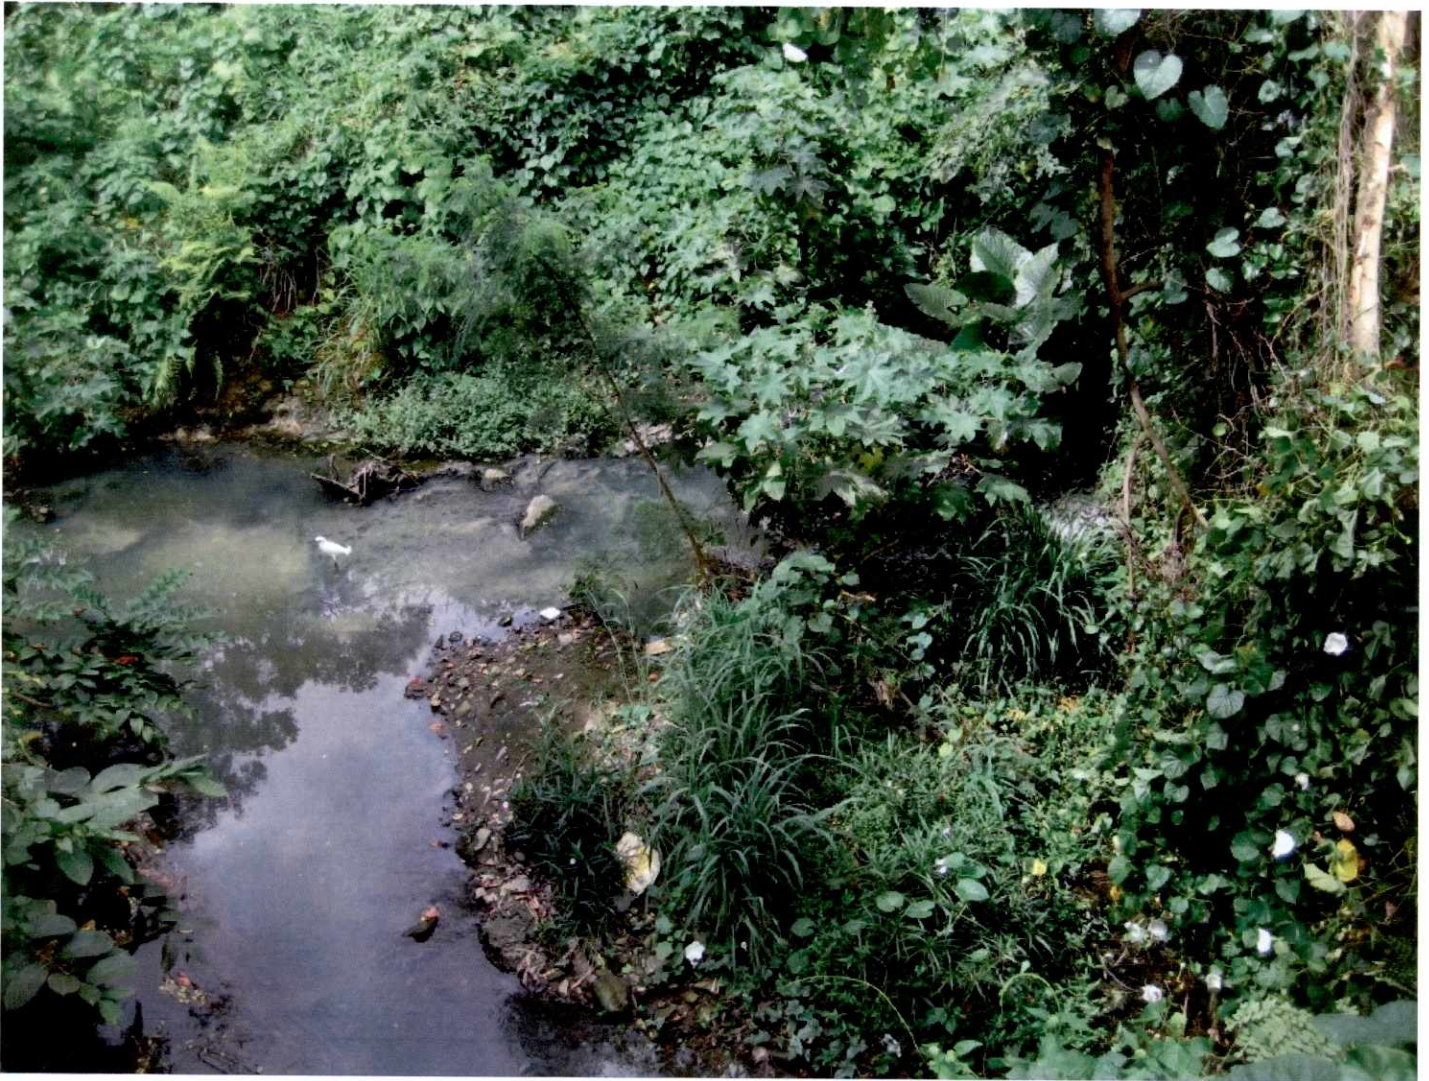
**March 13, 2012**

**IMG\_2703** – Photo taken on March 13, 2012 by EPA Inspector Alex O. Rivera. Additional view of the Juan Méndez Creek viewed from the José De Diego Street Bridge. Significant amounts of dry-weather flow with wastewater characteristics (odor, color, algae formation) were observed reaching the creek.

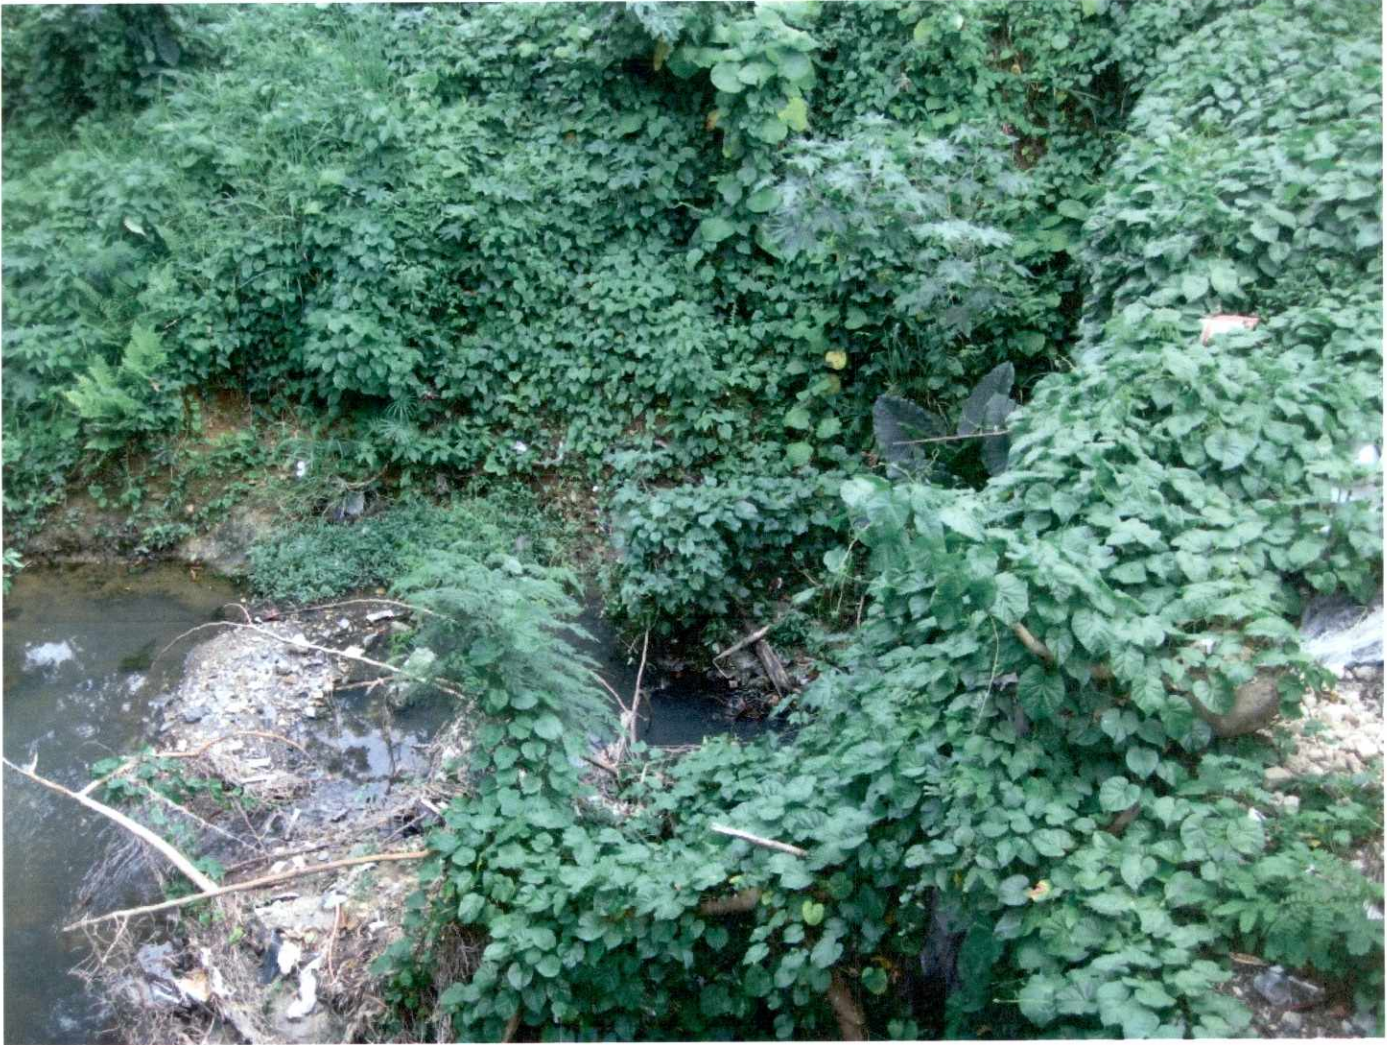
**April 23, 2012**

**IMG\_2908** – Photo taken on April 23, 2012 by EPA Inspector Alex O. Rivera. Additional view of the Juan Méndez Creek viewed from the José De Diego Street Bridge. Significant amounts of dry-weather flow with wastewater characteristics (odor, color, algae formation) were observed reaching the creek.

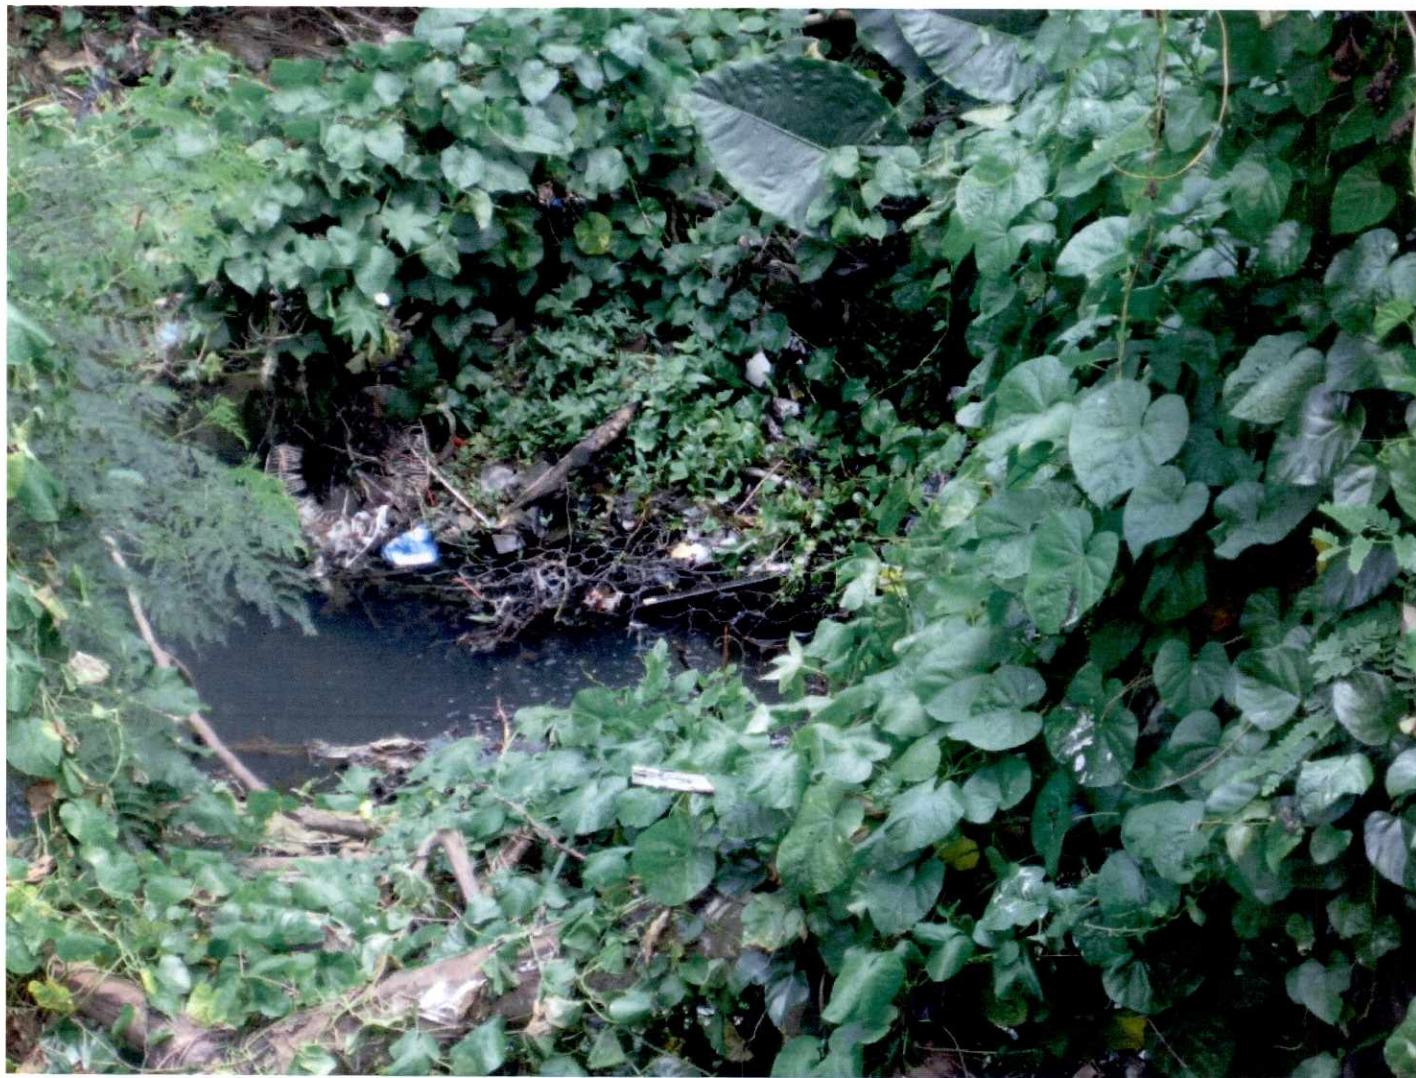
**May 9, 2012**

**IMG\_2990** – Photo taken on May 9, 2012 by EPA Inspector Alex O. Rivera. Additional view of the Juan Méndez Creek viewed from the José De Diego Street Bridge. Significant amounts of dry-weather flow with wastewater characteristics (odor, color, algae formation) were observed reaching the creek.

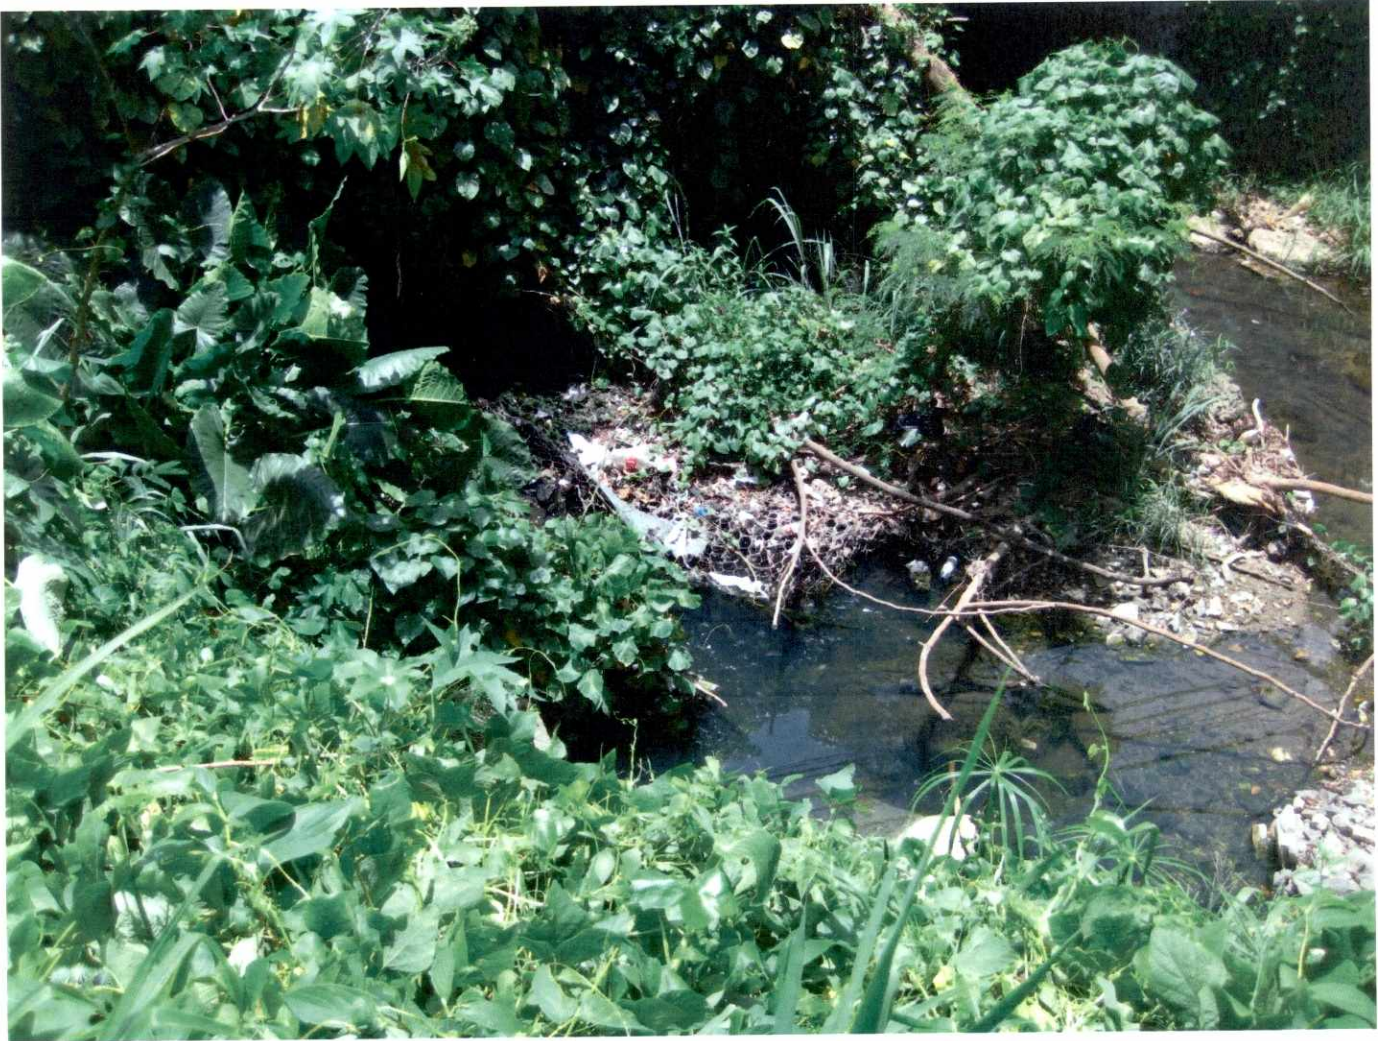
**June 13, 2012**

**IMG\_3366** – Photo taken on June 13, 2012 by EPA Inspector Alex O. Rivera. Additional view of the Juan Méndez Creek viewed from the José De Diego Street Bridge. Significant amounts of dry-weather flow with wastewater characteristics (odor, color, algae formation) were observed reaching the creek.

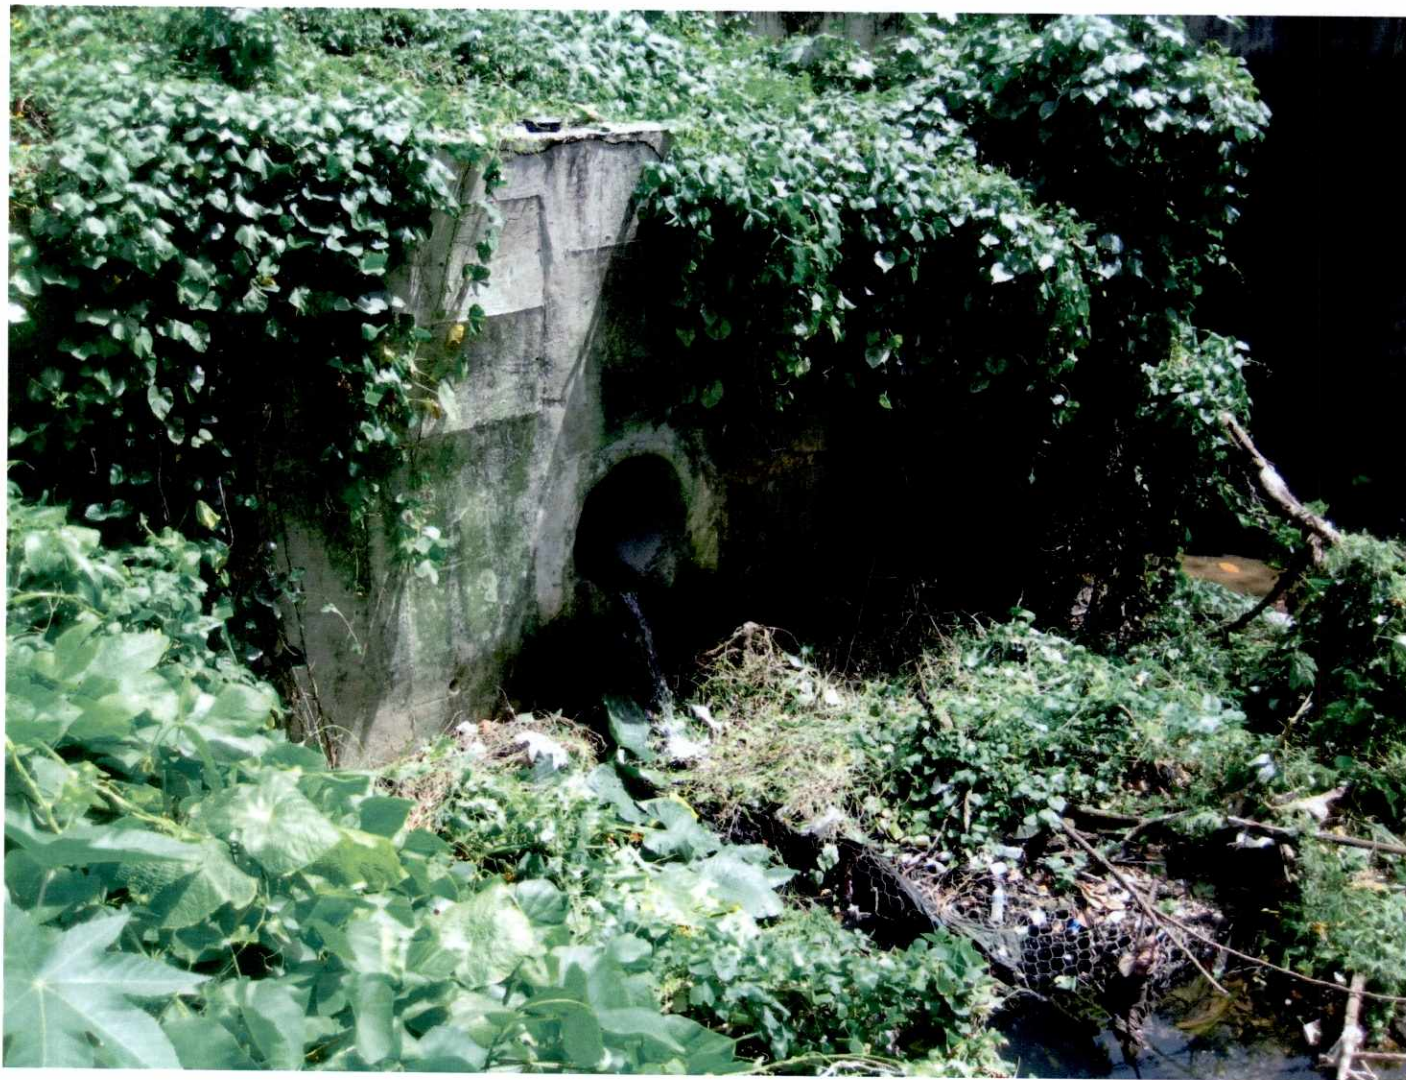
**July 17, 2012**

**IMG\_3609** – Photo taken on July 17, 2012 by EPA Inspector Alex O. Rivera. Additional view of the Juan Méndez Creek viewed from the José De Diego Street Bridge. Significant amounts of dry-weather flow with wastewater characteristics (odor, color, algae formation) were observed reaching the creek.

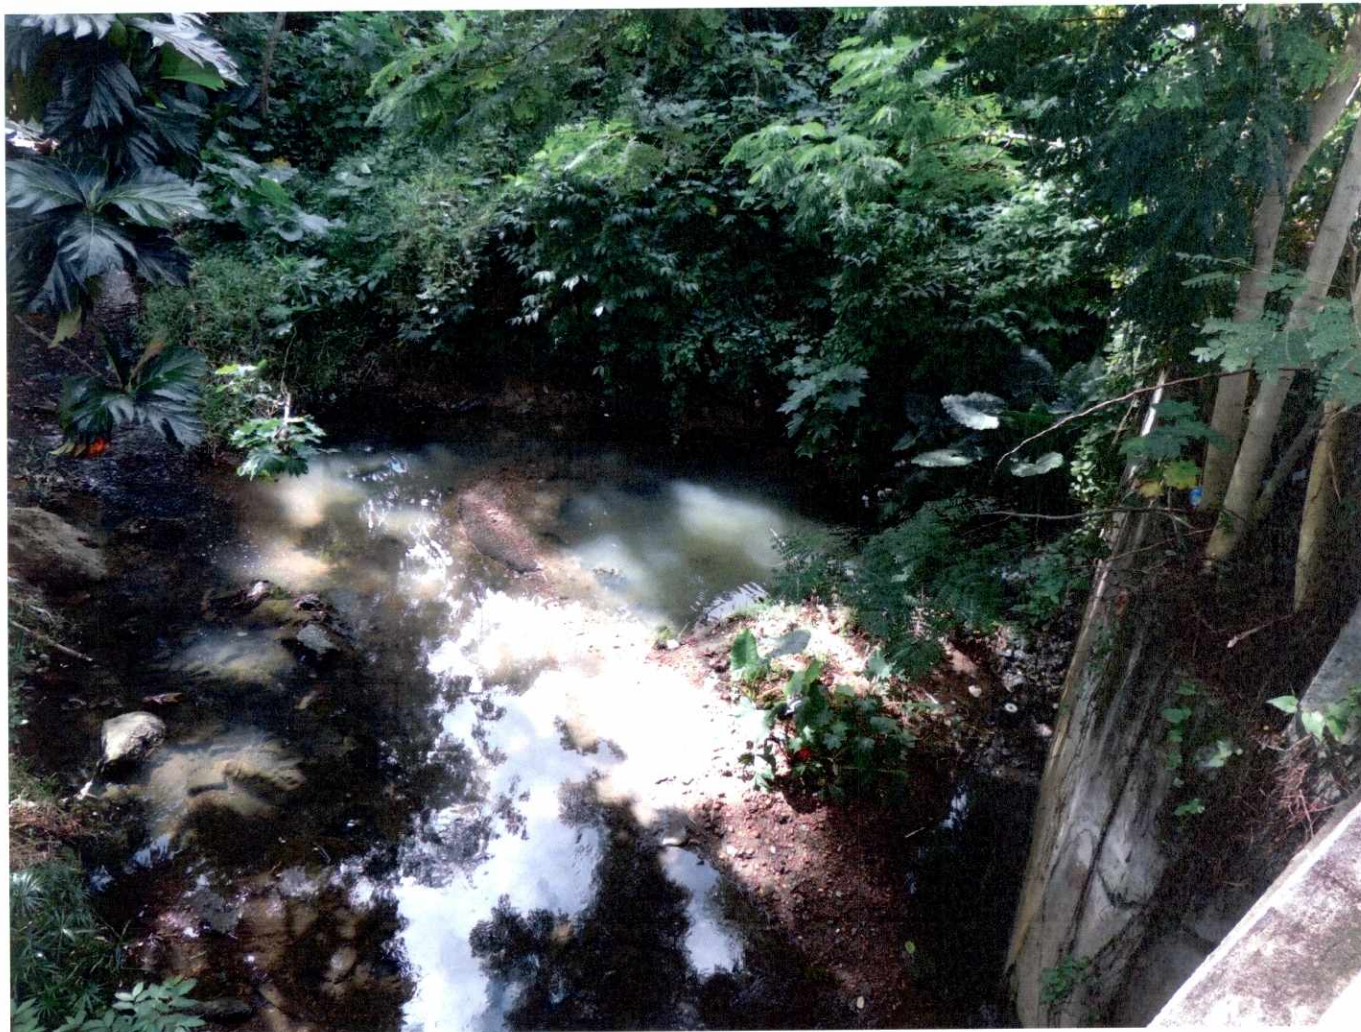
**December 2, 2014**

**DSCN1294** – Photo taken on December 2, 2014 by EPA Inspector Alex O. Rivera. Additional view of the Juan Méndez Creek viewed from the José De Diego Street Bridge. Significant amounts of dry-weather flow with wastewater characteristics (odor, color, algae formation) were observed reaching the creek.

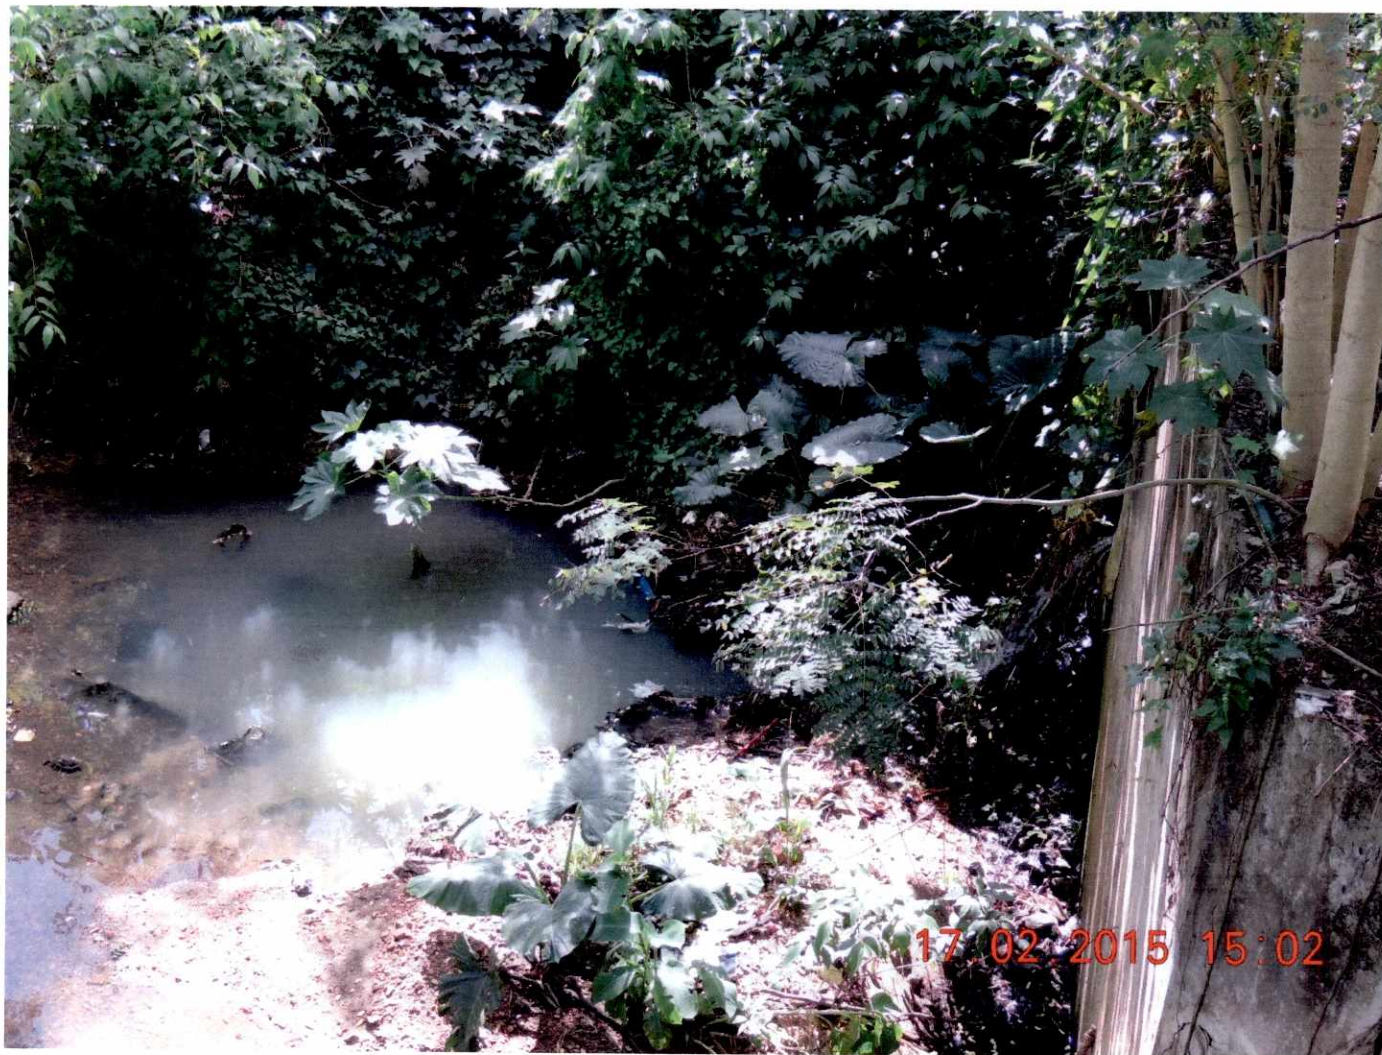
**February 18, 2014**

**DSCN1842** – Photo taken on February 18, 2014 by EPA Inspector Alex O. Rivera. Additional view of the Juan Méndez Creek viewed from the José De Diego Street Bridge. Significant amounts of dry-weather flow with wastewater characteristics (odor, color, algae formation) were observed reaching the creek.
